N350RT Upgrade Guide

This document only applies to upgrading the N350RT from the affected version (V9.3.5u.6389). Since the N350RT firmware version (V9.3.5u.6389) is vulnerable to hacker attacks that may cause network abnormalities, it is strongly recommended that all users of version V9.3.5u.6389 upgrade to the latest version.

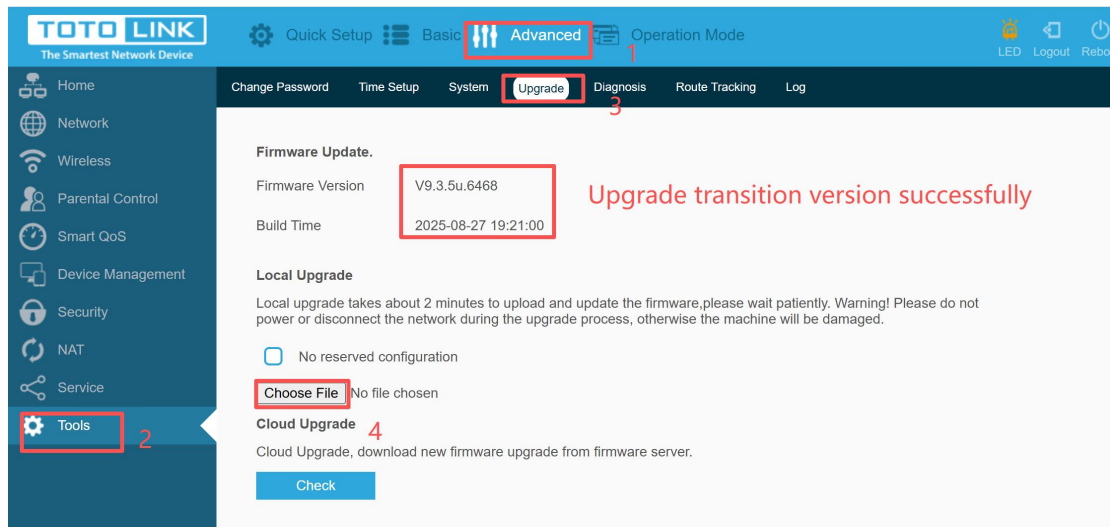
①、As shown in the figure below, after upgrading to the transitional version, the firmware version displayed on the web interface will be: V9.3.5u.6468. This indicates that the upgrade to the transitional version was successful. In this version, all function menus return a “404 Not Found” error. This is normal and serves as a warning that this version cannot be used normally and must be upgraded further.

404 Not Found
